LAKE CATHIE NSW 2445

Long term erosion detail - Compiled 23/07/2009

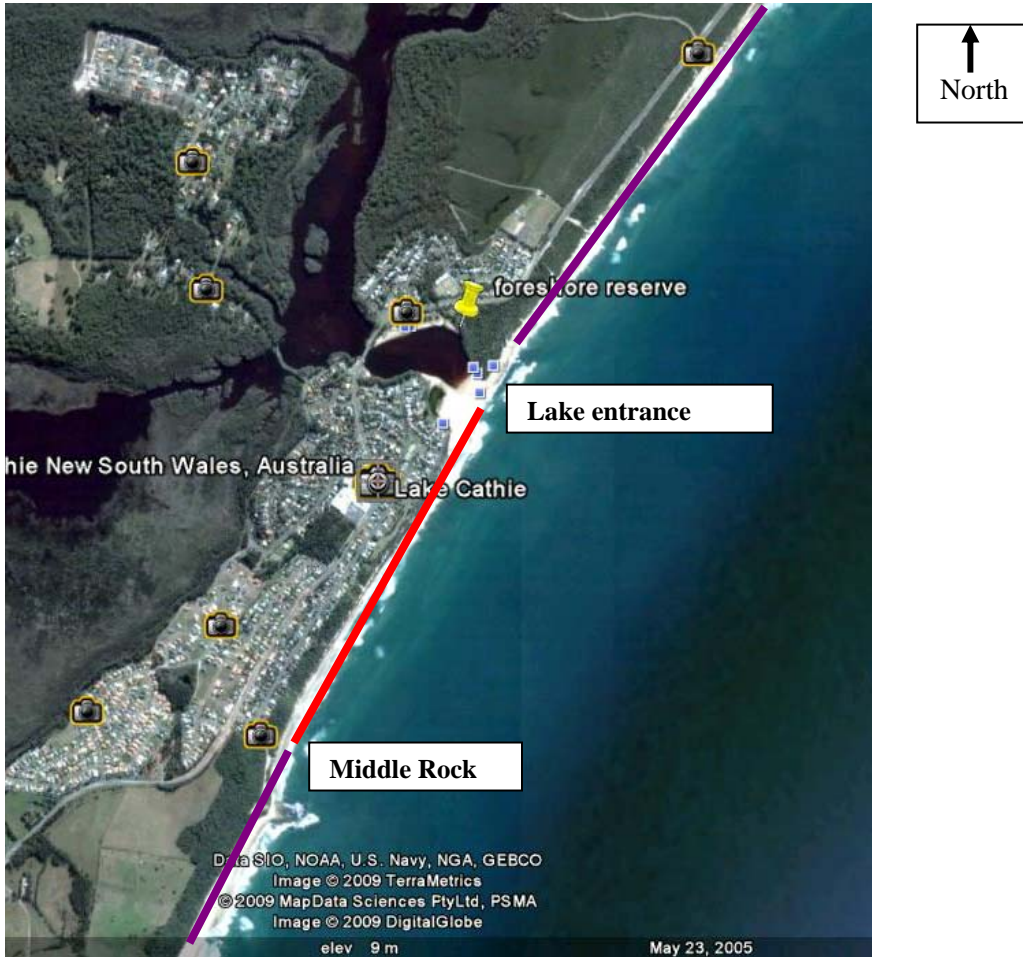
Red Line section of coastline

This is the section of the Lake Cathie coast that has been impacted by erosion for at least the past 25 years – Refer Hastings Municipal Council’s letter of 22 November 1985 confirming erosion between Lake Entrance and Middle Rock.

Some causes of this erosion include:

- Removal of vegetation from dunes
- Blow outs caused by unauthorised beach access.
- Storm Water outlets directly flowing from the dunes
- Long term failure to maintain the dunal structures
- Erosion from natural causes unable to be corrected by natural processes due to issues above.

Purple Line sections of coastline

The sections of the coastline north of the Lake Entrance and south of Middle Rock show minimal impacts of erosion – occasional erosion caused by storm events and other natural events are in time naturally corrected.

Neither of these sections has been used for residential development
